SENSENICH PROPELLER CO., INC.

FAQ FOR SERVICE BULLETIN SB2016-06B

Service Bulletin [SB2016-06B](#) contains all the definitive information for model and serial number applicability. This FAQ provides supplemental information to illustrate the following: model and serial number identification, previous service bulletins, hub model progression and pitch system variations, crack location and inspection recommendations, blade retention redundancy, and options available for compliance with the service bulletin.

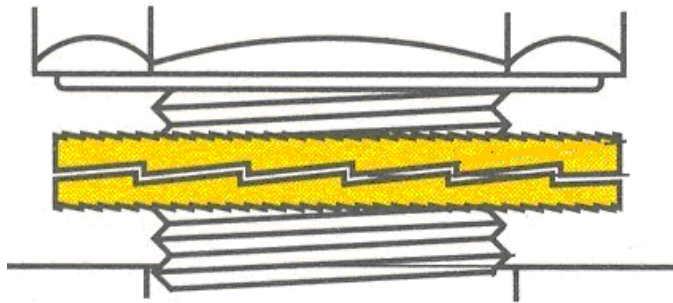
Nord-lock washers work in pairs with the ramped sides facing each other. See Figure 6.

During loosening, the Nord-lock washers may click loudly; this is normal. Inspect Nord-lock washers on the inside cam surfaces and outside serrations. Replace washers with excessive wear.

Figure 6. Nord-Lock Lock Washer

Lubricate acceptable washers with a light coating of engine oil or equivalent.

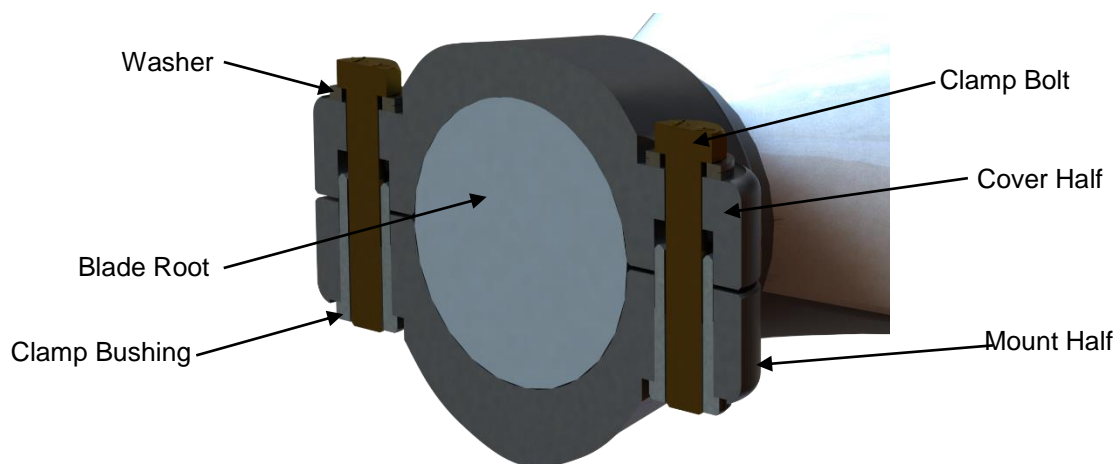
One design element which increases the retention safety for the 2A0 hub series is the incorporation of threaded clamp bushings. These bushings are press fit in the hub mount half and engage the hub cover half when the propeller blades are pitched and clamp bolts fully torqued. This ensures that the propeller clamp bolts do not carry any shear loads even if the hub cover cracks into two pieces.

NOTE: The clamp bushings provide blade retention backup *and do not change the 50 hour inspection interval for this service bulletin.*

Figure 6. Clamp Bushing Engagement into Hub Cover
